**Concorde Crash** In a photo taken from on board a nearby 747, Concorde can be seen taking off in flames. (Toshihiko Sato/AP)

### Concorde Crash Written by Kylan Dempsey

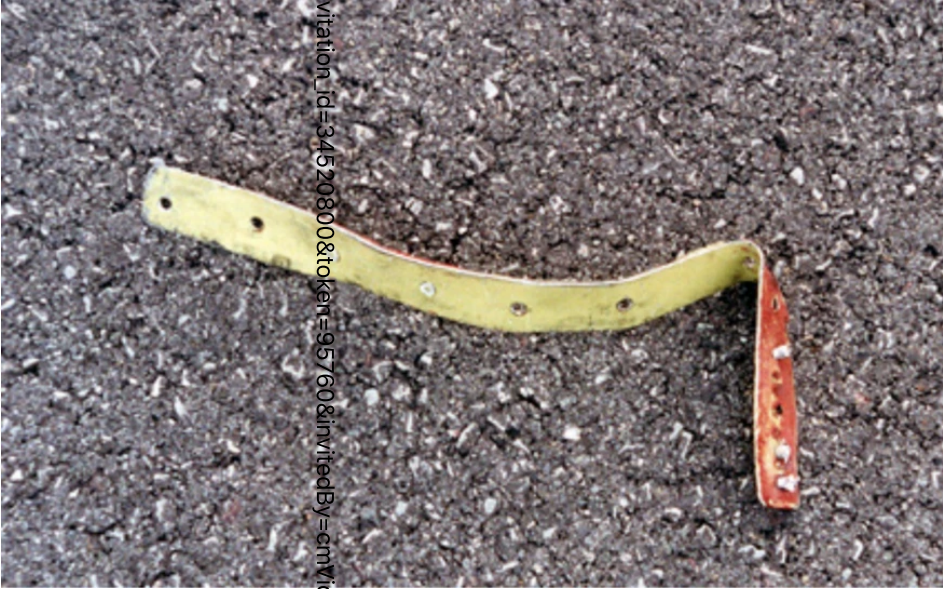
The metal strip hit by flight 4590, photographed where it came to rest on the runway. (BEA) Concorde Crash

Traveling at immense speed, the inner front tire on Concorde's left main landing gear ran over a metal strip lying edgewise on the runway. The strip instantly sliced deep into the highly pressurized tire, causing it to disintegrate with enormous violence. Within a fraction of a second, chunks of rubber and metal began to fly in every direction, ripping through wires, damaging the landing gear doors. And smashing into the underside of the wing. Fuel immediately began to stream from a hole in fuel tank #5, streaking back in front of the engine intakes and the landing gear bays, where a short-circuiting wire, damaged by flying debris, immediately set it alight.

One question remained, however: what was the metal strip, and where did it come from? This question quickly opened up an entirely parallel avenue of inquiry. Initial examination of the strip left investigators doubtful that it was even a part of an aircraft, given its extremely poor workmanship. It was 74 centimeters long, made out of a titanium alloy, and was covered in a red mastic adhesive; its width varied from 29 to 34 millimeters, and it contained several rivet holes of various sizes drilled at seemingly random intervals. However, the fact that it was made from titanium and was coated in aviation glue left little room for a non-aeronautical origin. Investigators eventually narrowed down the list of suspects to all the aircraft which took off from runway 26R between the last runway inspection and the departure of flight 4590.

Investigators concluded that this improperly manufactured and installed wear strip worked its way loose until it finally fell off as the DC-10 sped down runway 26R at Charles de Gaulle Airport on the 25th of July. Five minutes later, Concorde ran it over.

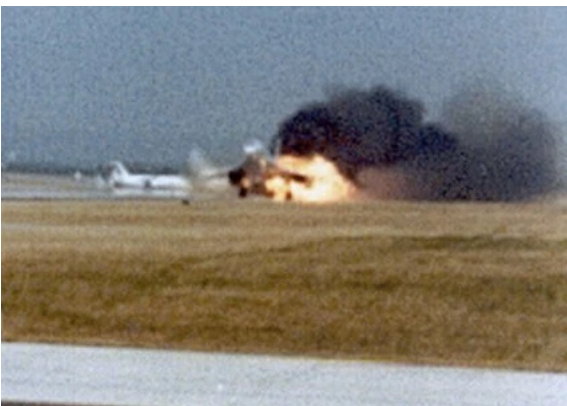
A photo taken from a nearby plane shows the first stage of the fire. (BEA) Concorde Crash

As a huge plume of flame erupted beneath the left wing. The ingestion of fuel and turbulent air caused both engines on that side to lose power. Violent surges rocked engines one and two as highly pressurized air from the combustion chambers forced its way back out through the inlets. The plane started to veer to the left. The asymmetric thrust and damaged left gear dragging it away from the runway centerline.

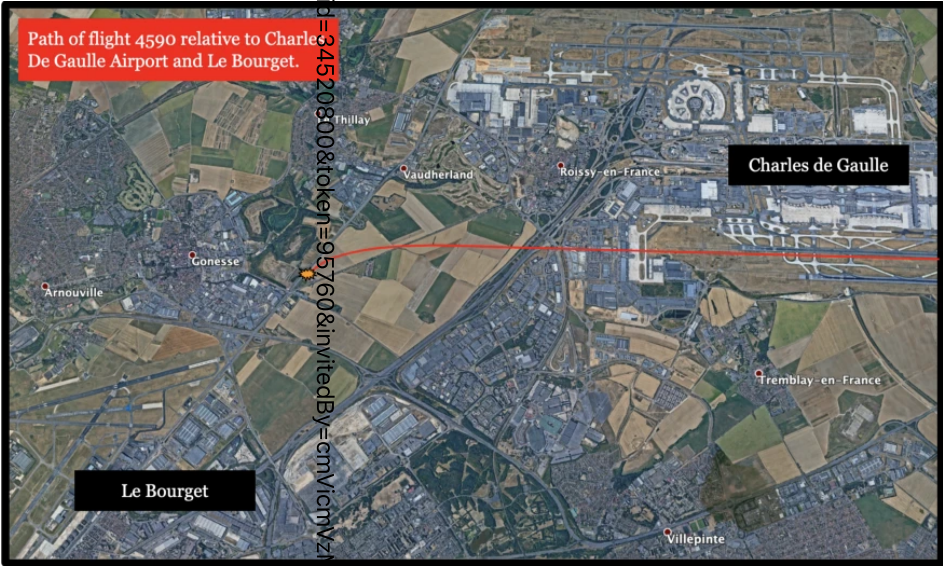
The path of Concorde’s brief flight. (Google + own work) Concorde Crash

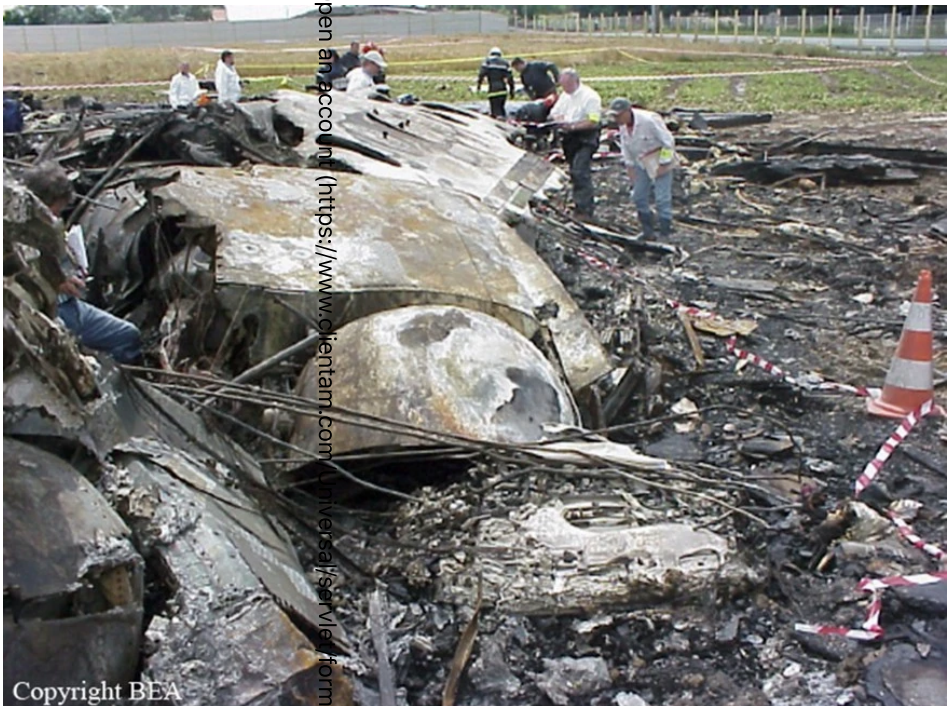
The main fuselage section contained most of the victims came to rest in the field. (BEA) Concorde Crash

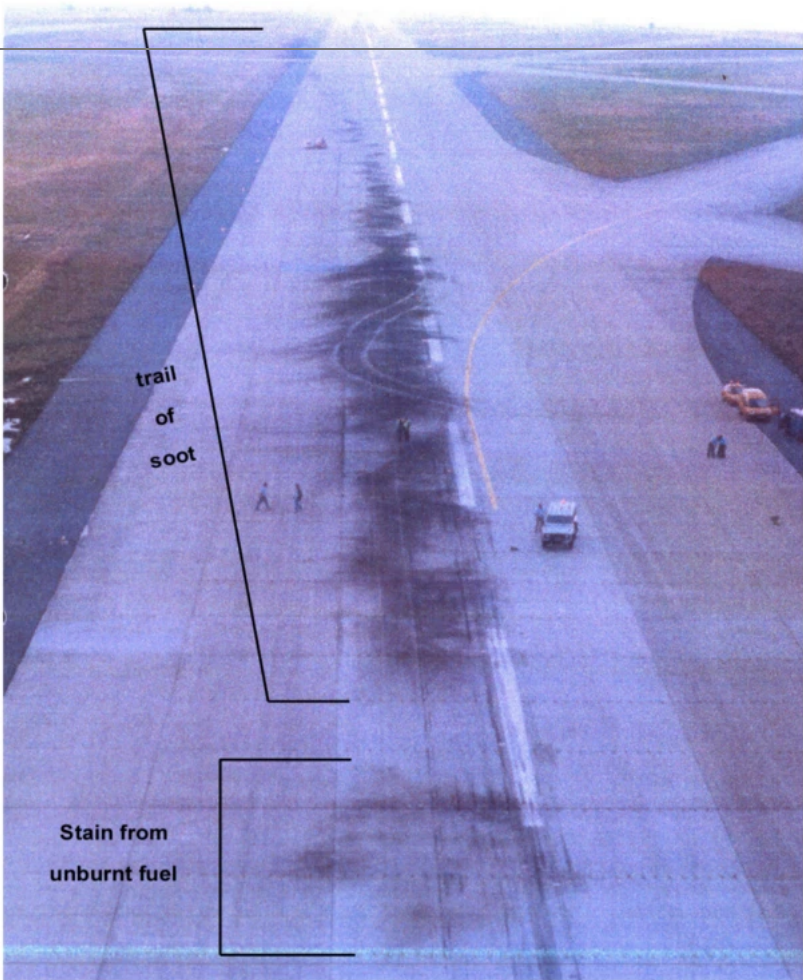
Figure 74: Aircraft track on takeoff

This aerial photo of the marks on the runway clearly shows that Concorde began to veer left only after it caught fire. (BEA) Concorde Crash

As the asymmetric thrust and damaged landing gear caused the plane to drift to the left. The captain feared a runway excursion or even a collision with the 747. Explaining his decision to lift off the runway before reaching the normal rotation speed. However, this act further destabilized the tenuous flight which Concorde did manage to achieve. By this time the pilots knew that something was wrong with at least engine #2. But, they had lifted off the runway before reaching the minimum climb speed with one engine out. Which was 220 knots (although reaching this speed may have been impossible under the circumstances). In fact the speed of the plane peaked at 200 knots. And then continuously fell until the end of the flight.

It has also been argued that one final factor played a role in the sequence of events. A missing spacer in the left main landing gear bogie. The spacer sits on the landing gear strut and helps keep the wheels aligned correctly. But the last several flights had been undertaken without it due to a maintenance error. A few days before the crash, Air France mechanics replaced the entire landing gear bogie, an operation which had never been performed at Air France before. During the process, the spacer was removed and the mechanics simply forgot to reinstall it.

In a 2001 article in The Guardian, journalists and Concorde pilots argued that the missing spacer might have been the cause of the drift to the left which forced Captain Marty to rotate early. The article even suggested that this drift to the left began before the plane ran over the metal strip. However, photographs of the runway clearly show that staining from the fire began near the runway centerline and only began to diverge later, proving that the plane was properly centered when it first struck the object. Furthermore, the BEA, the French accident investigation agency, later calculated that even the maximum possible landing gear misalignment induced by the missing spacer would have produced negligible drag in comparison to the power delivered by the plane's engines, and would not have resulted in a noticeable pull to the left.

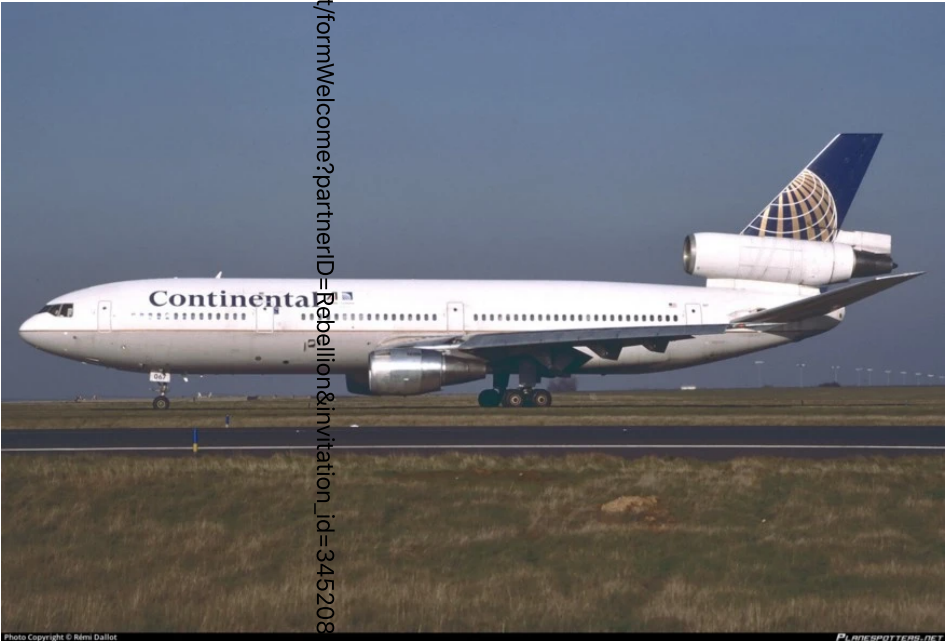
N13067, the plane which dropped the metal strip. (Remi Dallot) Concorde Crash

Then, on August 30th, a BEA investigator happened to spot one of these suspect airplanes parked at the gate at Charles De Gaulle Airport. The plane was a Continental Airlines McDonnell Douglas DC-10. Which took off from runway 26R five minutes before Concorde on the day of the accident. Furthermore, something about the plane's left engine looked strange. The BEA decided to track the plane down. Finally catching up with it in Houston, Texas a day or two later. When they inspected the plane's left engine. They found the smoking gun: a metal wear strip, which had been attached to the inside of the engine cowl door using red mastic, was missing.

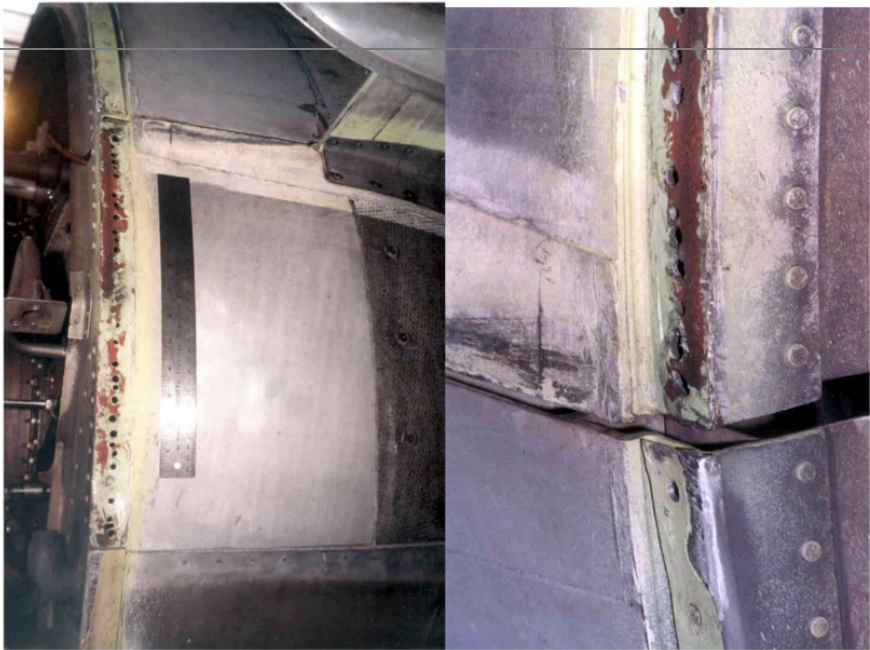
Figure 52: Pictures showing the position of the wear strip

The place where the missing wear strip was previously attached. (BEA) Concorde Crash

The wear strips were relatively unsophisticated lengths of metal. Attached to the inside edges of the frame of the cowl door. In order to absorb wear and tear in lieu of the door itself.

While the plane was in flight, the door tended to oscillate slightly in its frame, causing wear to the door; but if the door closed flush against a wear strip made of a less durable material, the strip would wear down instead. Because the wear strips were so minor and expendable. Mechanics were allowed to fabricate new ones directly on site, as long as they followed certain guidelines.

It turned out that several new wear strips installed on this plane in early June by a company in Tel Aviv were faulty, and just a couple weeks later a Continental mechanic saw one of them sticking out of the gap between the door and its frame, a highly abnormal position. He consequently removed the broken wear strip and set about making a new one. However, he did not follow the directions correctly; he made the strip out of titanium instead of stainless steel; he didn't cut it evenly. And he made the mistake of not ensuring that his rivet holes did not correspond with the existing holes.

The result was a wear strip with an awkward shape. Full of holes that didn't necessarily contain rivets, and barely fit into its assigned space. This type of poor workmanship appeared to be commonplace. Since the wear strip next to it was too long, was missing a rivet. And didn't sit flush with the support, which caused difficulty closing the cowl door properly.

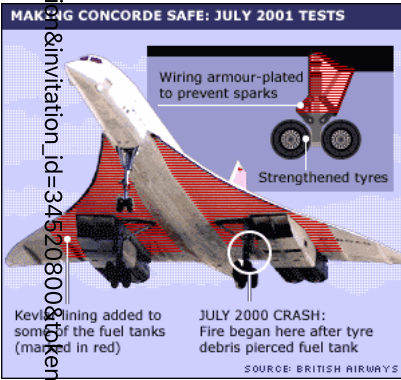
A news graphic shows the modifications undertaken after the crash. (BBC) Concorde Crash

The disaster also raised safety concerns about Concorde itself. Shortly after the crash, French and British authorities made the decision to ground all Concorde until the cause of the accident could be determined. This decision ended up lasting more than a year while the Concorde fleet was retrofitted with stronger tires and Kevlar-lined fuel tanks.
